MTL TR 89-68

EFFECTS OF HOT CORROSION ON THE ROOM TEMPERATURE STRENGTH OF STRUCTURAL CERAMICS

JEFFREY J. SWAB

July 1989

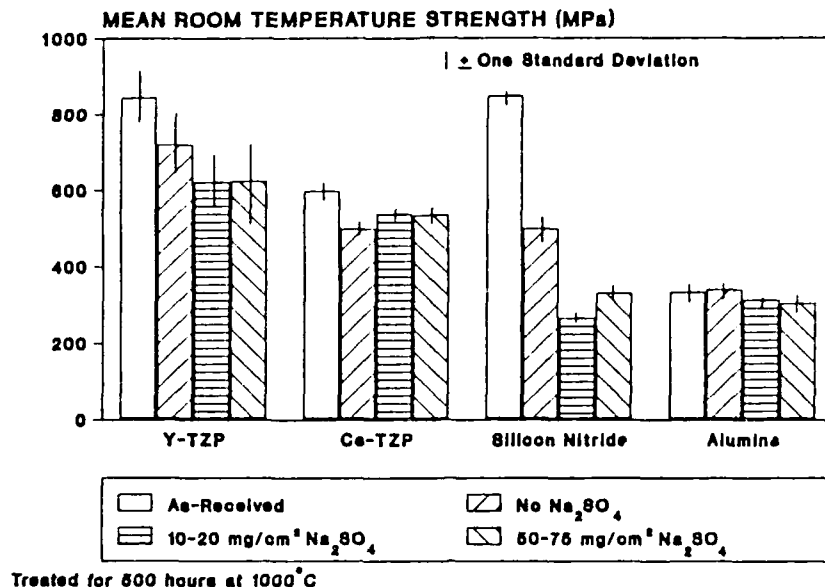
Figure 1. Mean room temperature strength after corrosion with and without sodium sulfate.

The results of the room temperature flexure strength testing, Figure 1, show the Ce-TZP to be the most resistant to strength degradation after exposure to molten sodium sulfate at 1000°C, followed by the alumina and the Y-TZP. The Si_3N_4 shows the largest strength loss after exposure.

The slight strength reduction of the Ce- and Y-TZP after 500 hours at 1000°C without Na_2SO_4 can be attributed to the fact that these materials are transformation-toughened ceramics and are susceptible to overaging when exposed to elevated temperatures for a prolonged time. The addition of a small amount of a rare earth oxide, such as CeO_2 or Y_2O_3 , along with an appropriate processing technique, allows for the retention of metastable tetragonal zirconia at room temperature. However, when overaging occurs, the tetragonal zirconia transforms to the stable monoclinic phase, resulting in a reduction in strength.¹⁵⁻¹⁸

The addition of Na_2SO_4 to the long time/high temperature exposures does not cause any further strength reduction in the Ce-TZP, and only minimal reduction in the alumina. However, the Y-TZP and, to a greater extent, the Si_3N_4 experience significant reductions in strength.

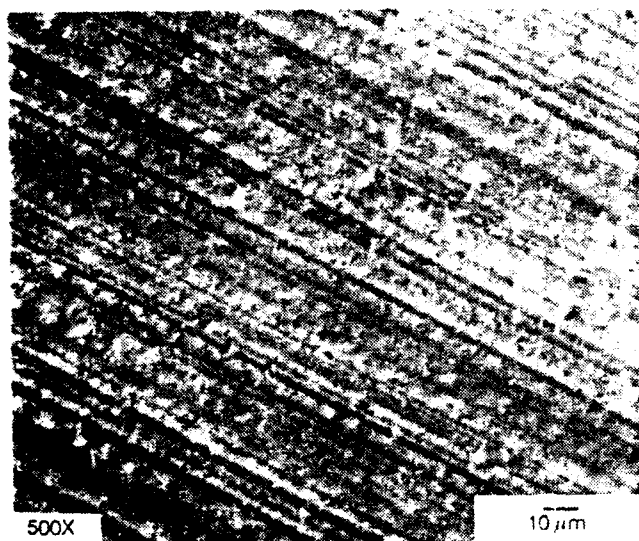
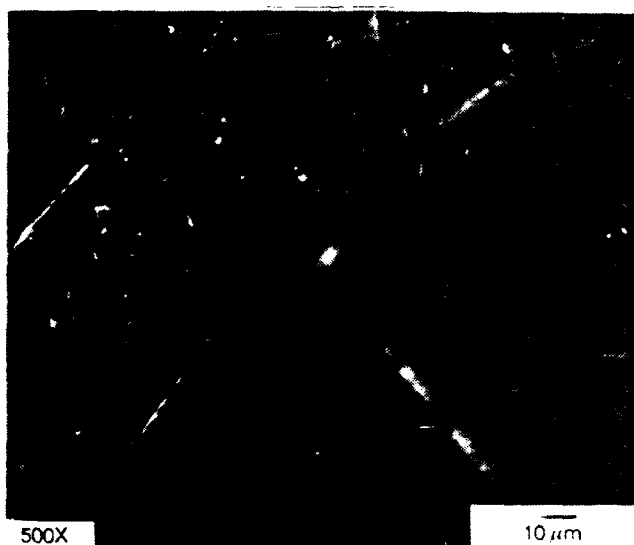
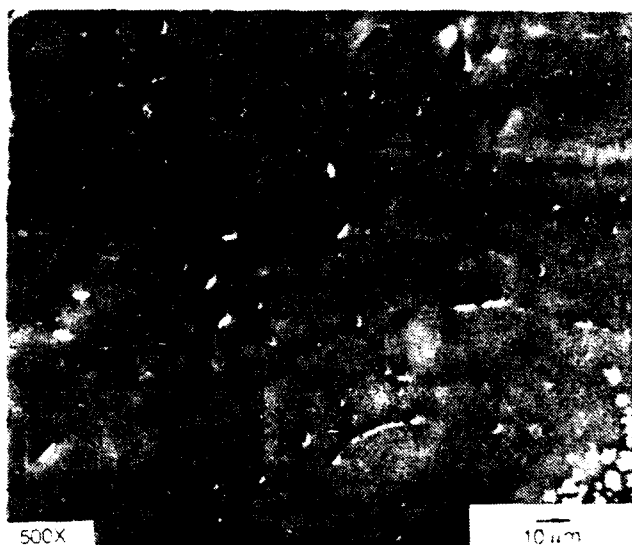
(a) As-Received

(b) After 500 Hours at 1000°C without Na_2SO_4

(c) After 500 Hours at 1000°C with 10 to 20 mg/cm^2 Na_2SO_4

(d) After 500 Hours at 1000°C with 50 to 75 mg/cm^2 Na_2SO_4

Figure 2. Tensile surfaces of Si_3N_4 .

The Si_3N_4 has a significantly large reduction in strength (~40%) when exposed to the same treatment conditions. An oxidized layer of SiO_2 forms when Si_3N_4 is exposed to temperatures in excess of 1000°C for a prolonged time^{20,21} (Figure 2b). The loss of strength is due to the creation of oxidation pits as shown in Figure 3b. Alumina does not undergo phenomena such as these. Thus, there is no reduction in strength as a result of this exposure.

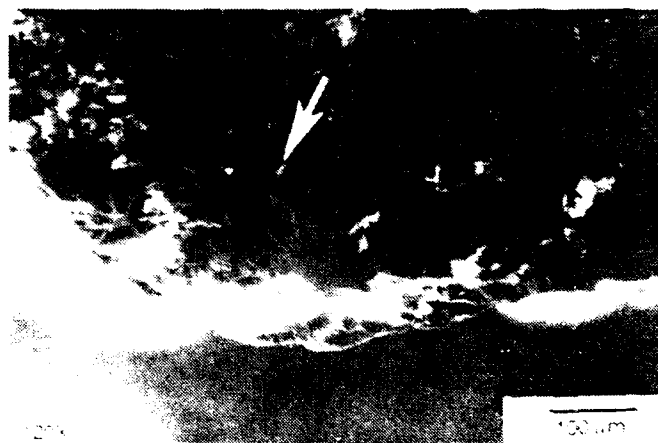
(a) As-Received - Machining Damage

(b) After 500 Hours at 1000°C without Na_2SO_4 - Oxidation Pits

(c) After 500 Hours at 1000°C with 10 to 20 mg/cm^2 Na_2SO_4 - Corrosion Pits

(d) After 500 Hours at 1000°C with 50 to 75 mg/cm^2 Na_2SO_4 - Corrosion Pits

Figure 3. Fracture origins of silicon nitride. Note the change in magnification from (a) and (b) to (c) and (d).

Examination of the fracture surfaces of the TZPs and the alumina showed that the type of strength-limiting flaw did not change after exposure to molten sodium sulfate, Figures 5 through 7. This was not the case for the Si_3N_4 . It experienced an additional strength loss of ~25% when exposed to Na_2SO_4 , due to a change in the flaw type and size. The typical flaw for the as-received material was machining damage, Figure 3a, and that for the bars treated without any Na_2SO_4 was oxidation pits, Figure 3b. For the bars exposed to Na_2SO_4 , the flaw also a pit, but this time a corrosion pit, Figures 3c and 3d, which are on the order of 10 times larger than the oxidation pits. Analysis of the pit contents showed the presence of a small amount of Na in addition to Si and Mg. The presence of Na, as well as the glassy-like appearance of the contents of the corrosion pit, indicates that a sodium-silicate glass has been formed as outlined in Equation 5. The Mg is due to the addition of MgO as a hot-pressing aid.

Several studies have seen similar strength reductions^{8,9,11} and changes in the strength-limiting flaws.^{8,9} Bourne and Tressler⁸ suggest that corrosion occurs due to attack of the oxide grain boundary phase, which creates the pits. X-ray analysis of the surface of the Si_3N_4 bars showed an increase in cristobalite with heat treatment time, while the addition of the sodium sulfate caused peak broadening indicating the formation of an amorphous layer, possibly a sodium-silicate glass.
